**Condition & Value Survey Report**

File #: 17072

Acting at the request of [REDACTED], attending surveyor proceeded to Crowley’s Yacht Yard Lakeside, 3434 East 95<sup>th</sup> Street, Chicago, IL 60617, under the date of June 14, 2017 and there did survey the 37’ sloop while she was laid-up ashore. The purpose of the survey was to ascertain the condition and value of said vessel. The vessel has been used for pleasure purposes.

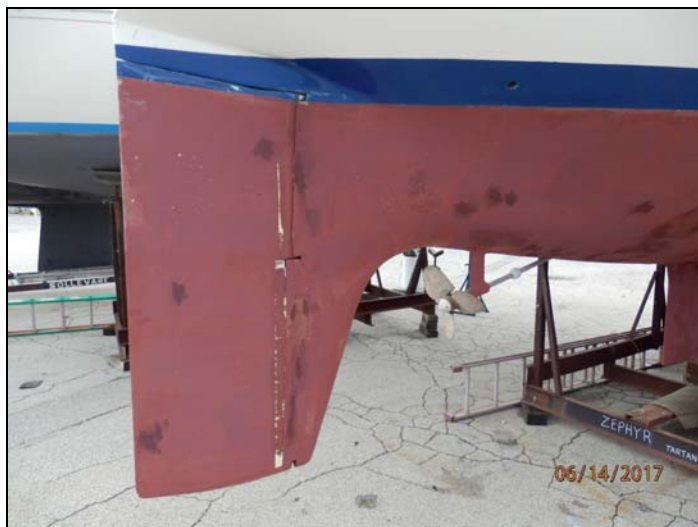
*Rudder*

Somewhat dull repercussions were gained from each side of the rudder. Level 3 readings were gained from the noted surfaces.

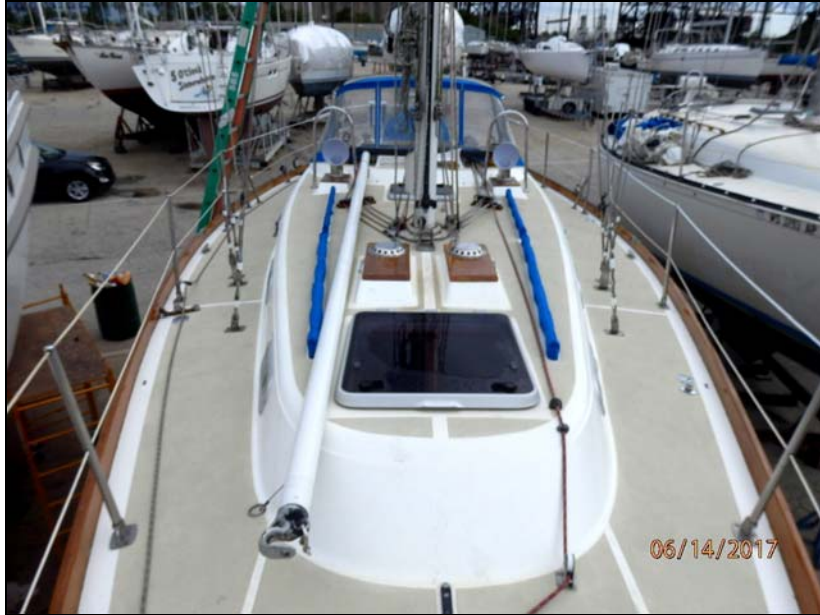
*Looking Aft From Foredeck*

After boarding the vessel, the attending surveyor inspected the deck and cabin housing by using the same methods as used on the undersides. Our visual inspection showed the noted surfaces to present very well. Moisture readings gained from the deck and cabin housing surfaces registered in the Level 1 – 3 ranges. The L-3 readings were gained from at and or around the following: Anchor rode deck pipe (port), mast partners, portions of the genoa tracks, and fuel fill plate. Dull repercussions were gained from a small area located several inches aft of the mast partners.

Survey was conducted while the mast was stepped. Inspection of the mast above 6' was necessarily visual only. Our inspection of the turnbuckles, swaged fittings and lower lengths of the shrouds showed no visible damage or unusual wear. All clutches, winches and organizers functioned as intended.

1. Test the deck and all attachments for water leakage and reseal as found necessary.
2. Equip the surveyed vessel with up-to-date visual distress signals and a Type IV Flotation Device (USCG and State Regulations).

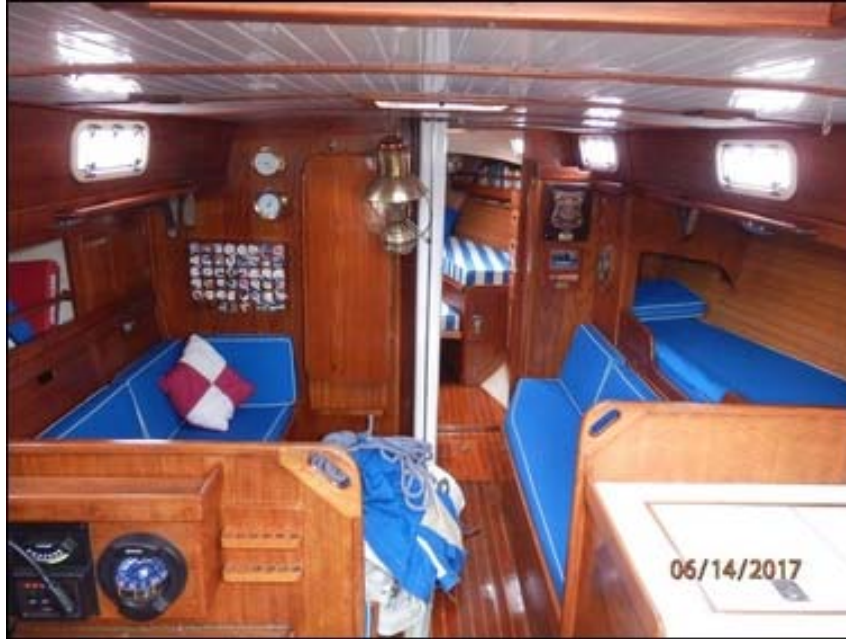
*Cabin Spaces*

Our next inspections led us below deck, where we found sleeping accommodations for six. The cabin spaces were well-appointed with solid teak and teak veneers. The teak & holly sole showed minimal amounts of wear and tear. All seat and berth covers presented very well to our visual inspections.

A search for signs of past water leakage from overhead sources showed some warping of the panels above the pilot berth. Dried water trails were noted at and below the mast partners.

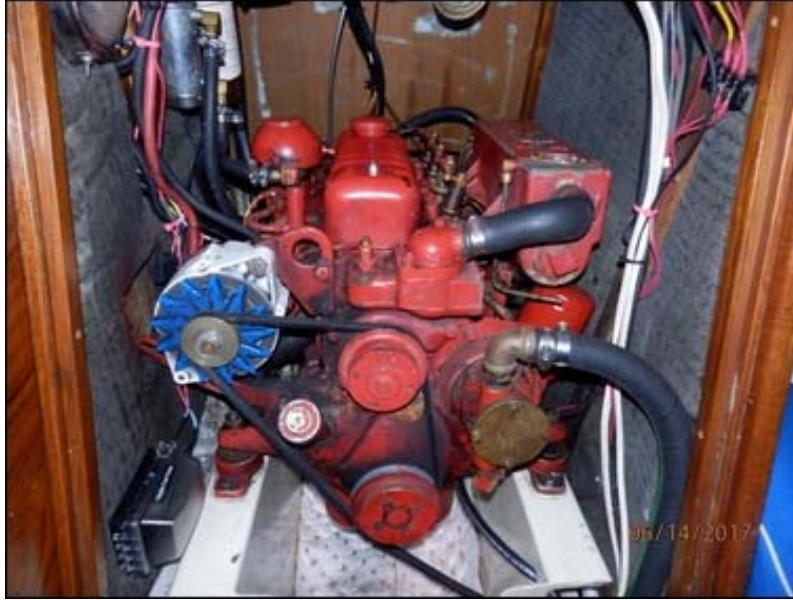
*Westerbeke Inboard Engine*

The overall appearance of the exterior of the inboard engine was classified as average. No indicators for a prior overheat occurrence were observed. All belts and hoses were in a good and serviceable condition. All engine mounts appeared to be properly secured. The coolant in the overflow reservoir was within the recommended range.
