**Condition & Value Survey Report**

File #: 17072

Acting at the request of [REDACTED], attending surveyor proceeded to Crowley’s Yacht Yard Lakeside, 3434 East 95<sup>th</sup> Street, Chicago, IL 60617, under the date of June 14, 2017 and there did survey the 37’ sloop while she was laid-up ashore. The purpose of the survey was to ascertain the condition and value of said vessel. The vessel has been used for pleasure purposes.

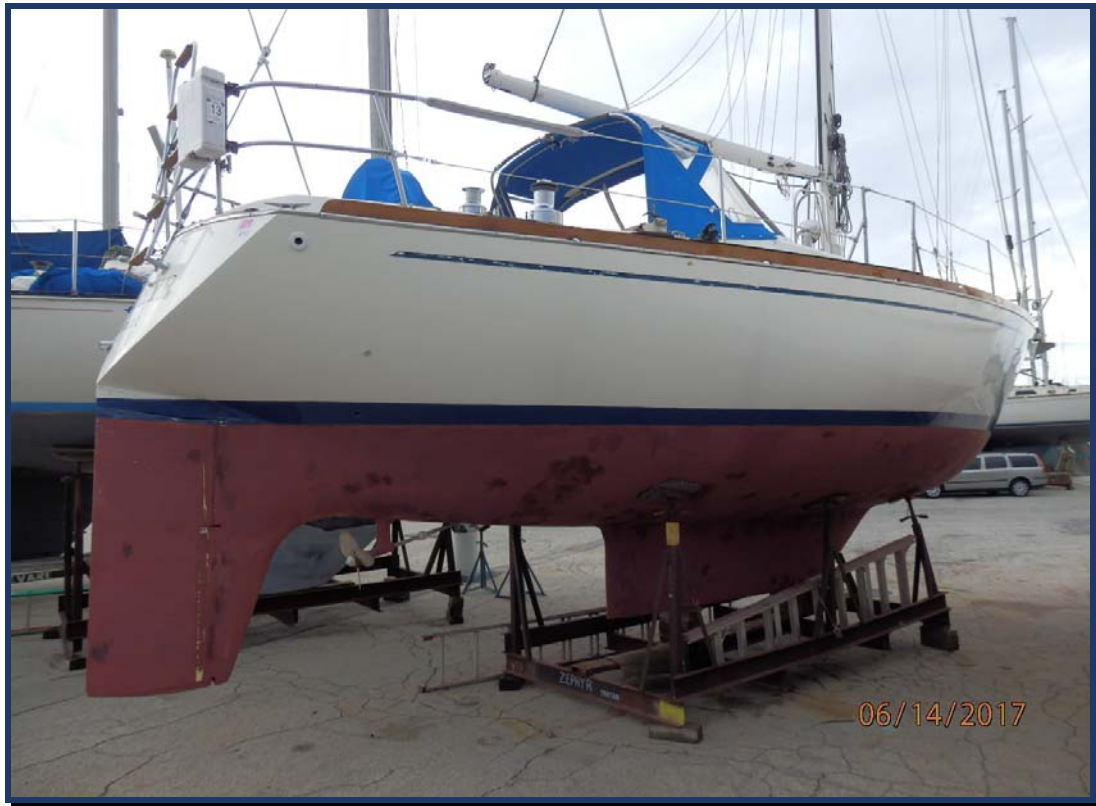
*"Zephyr"*

The surveyed vessel is a 37' sloop with a skeg-hung rudder, centerboard keel, and an auxiliary diesel inboard engine. The overall cosmetic appearance of the vessel was classified as above average. Any exceptions are noted below.
