# SCHUSS MARINE SURVEY, LLC

1987 Sabre 36

*PROBE*

# REPORT OF MARINE SURVEY

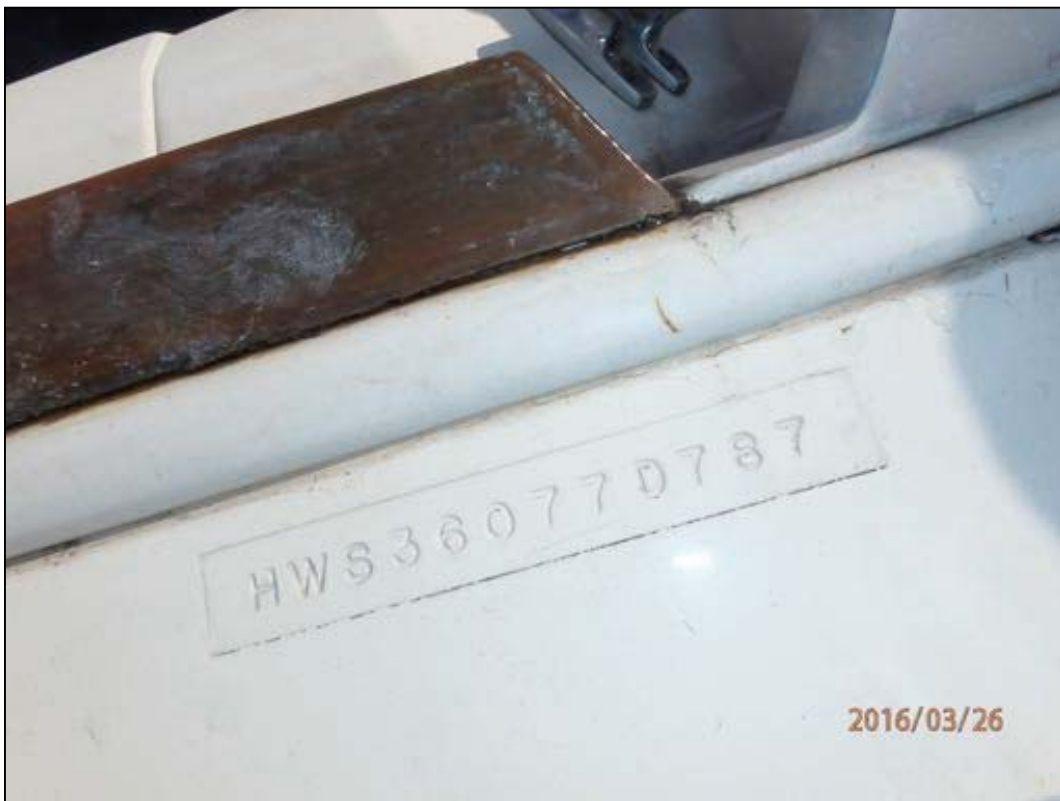
## VI. HULL IDENTIFICATION NUMBER

I certify that the rubbing of the HULL IDENTIFICATION NUMBER which appears below on this document was personally taken by the undersigned on the date indicated below.
